Manhole Inspection Summary

Manhole # S21M1_004MH

Insp Date: **4/30/08 9:49 AM**

Location Address: **2135 hollins ferry-patapsco shopping center**

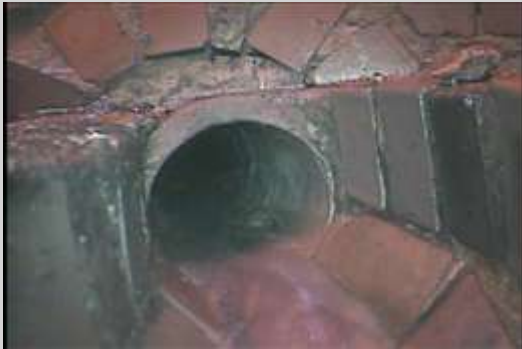
12 O'Clock Outflow

6 in. Circular Gravity Sewer
Pipe Out @ 12 O'Clock

Pipe Height: **6** (in.) Rod and Bar (Angled)
Pipe Material: **Clay** ☐ Pipe Lined
Invert Depth: **6.23** (ft.) Flow Characteristics: **Slow**
Deposits: ☒ None ☐ Mud ☐ Sludge ☐ Debris ☐ Grease
Silt Depth: **0** (in.) Deposits Extent:
Infiltration: **None** Pipe Seal Cond: **Sound**
